Historic Resources, con't

Boat House

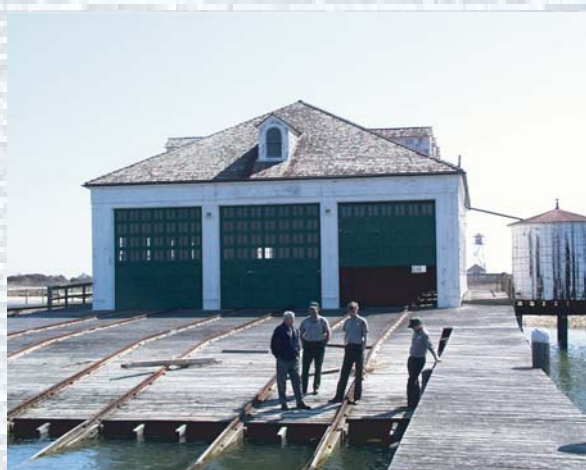
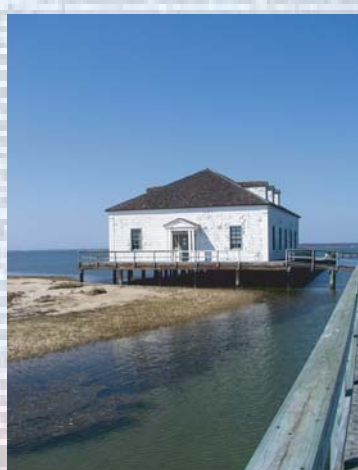
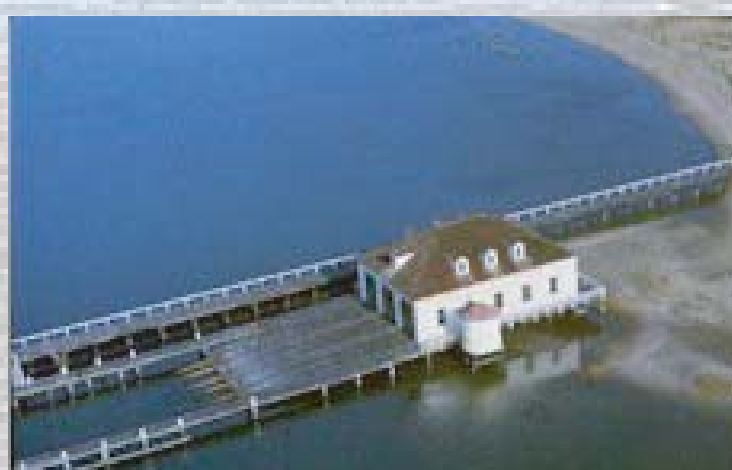
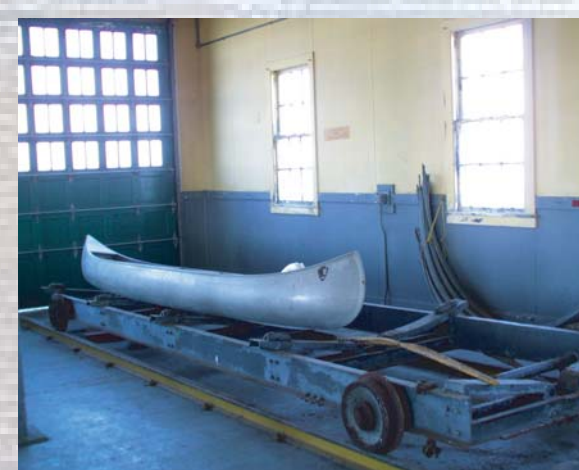
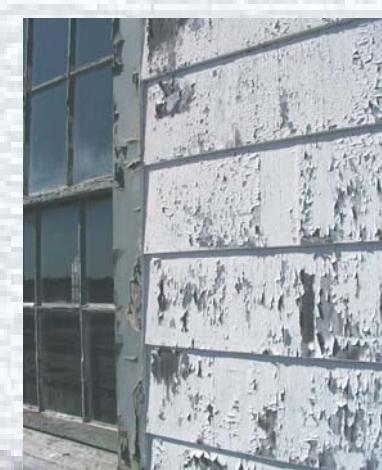
Condition: Fair **Built:** 1938 **Preserved:** 1970 **Stabilized:** 1994 **National Register Status:** Eligible, Local

Physical Description: 1-1/2 story frame boathouse, 46'x62'; built on 10'-12' pilings 5' to 7' above sand grade. Front entry porch with pilasters; hipped roof with dormers; cistern on pilings on west side. Surrounded by boardwalk. Iron rails & wood ramp on north side. Paint failing on wall surfaces; roof will need replacement soon.

Materials: Walls - weatherboard; Roof - shingle; Foundation - wood

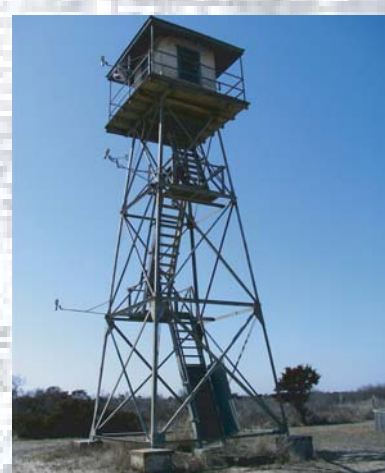
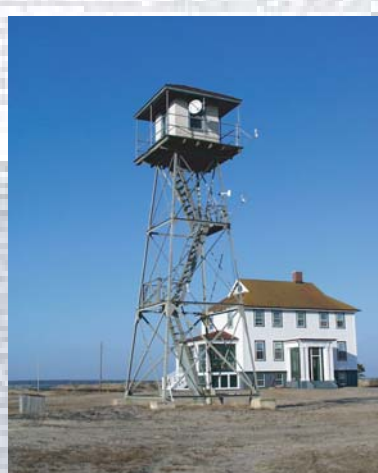
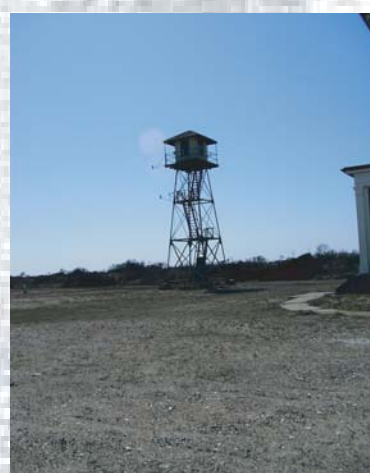
Tower

Condition: Fair **Built:** 1922 **Altered:** 1938-1939 **National Register Status:** Eligible, Local

Physical Description: Steel tower, 37' high, constructed of steel angles and resting upon four concrete pads; wooden platform, 12' square span top of tower & 2 intermediate platforms at wooden ladder to top; 7' square frame structure at top platform. Has some structural deterioration.

Materials: Superstructure - wood and steel; Substructure - concrete
